**BARN BLUFF
LANDSCAPE GUIDELINES**

BARN BLUFF PARK, RED WING, MINNESOTA

March 2015

produced by **DF / DAMON FARBER**

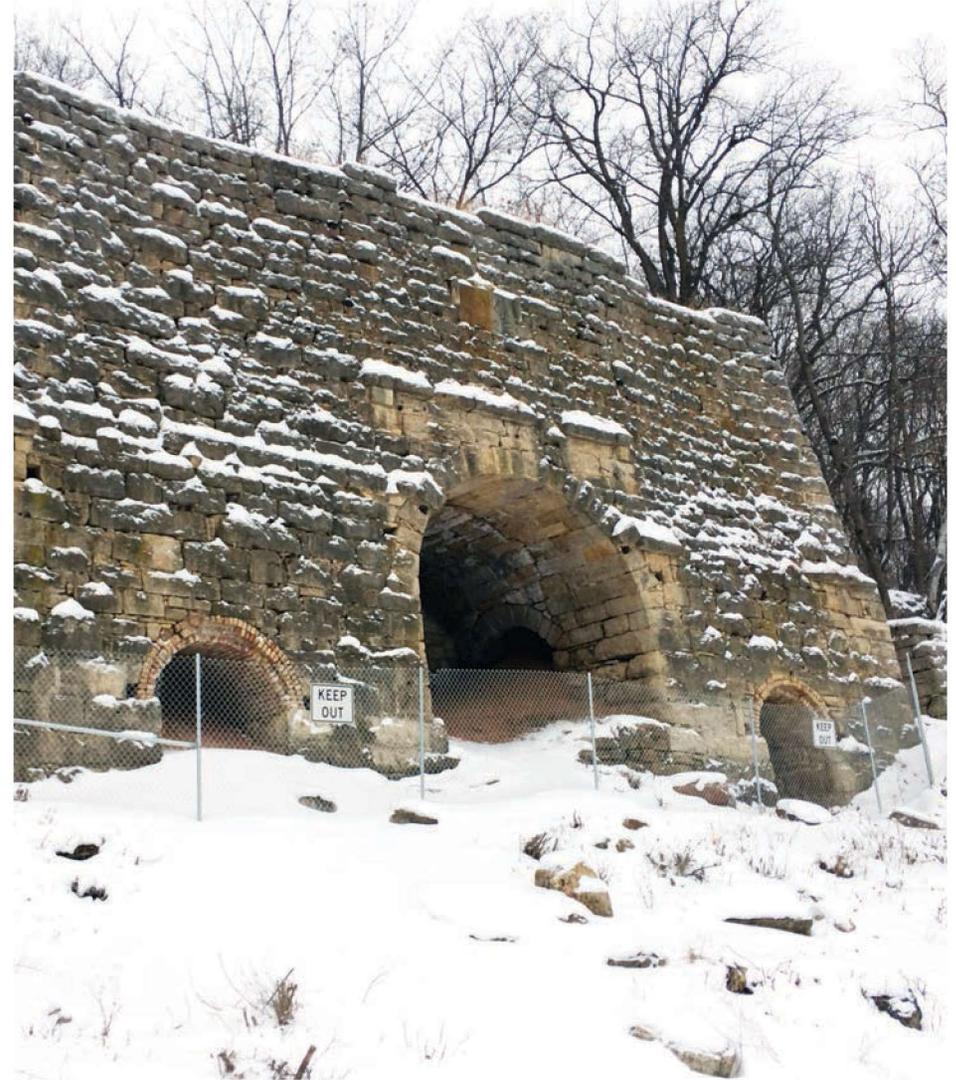
(Fig. 1.1) Historic Kiln Site

New structures should consider the rustic precedent of the former kiln sites, the forms of the precast concrete treads, the steel handrails, and former industrial design patterns.

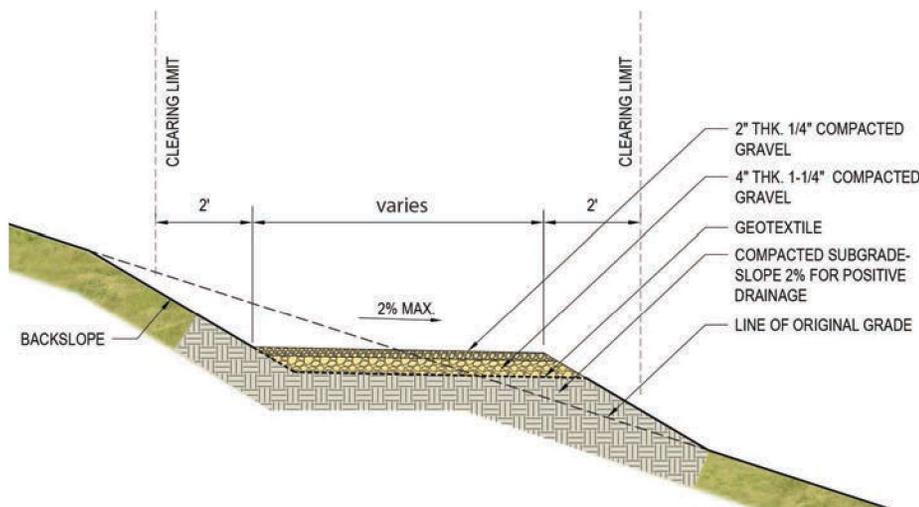
(Fig. 1.3) Gravel Trail Construction

- ▶ If a more engineered solution must be introduced such as a Class V aggregate (Fig. 1.3) to solve erosion problems or build up grade, care should be taken to select aggregate from the local area.

- conditions of the trail system, there may be some cases where Class V limestone may be required as a stable, durable solution over packed earth trails. Given the historic limestone quarry on site, it can be reasoned that this indigenous material was likely used as an inexpensive and readily available material for access routes.

- ▶ When initially installed, Class V limestone may be bright and quite varied from the native soil. However it will eventually weather and be less obvious. A mix of native sand and Class V will lessen the visual impact. Maintaining the narrow character of the trail is important in trail improvement work.

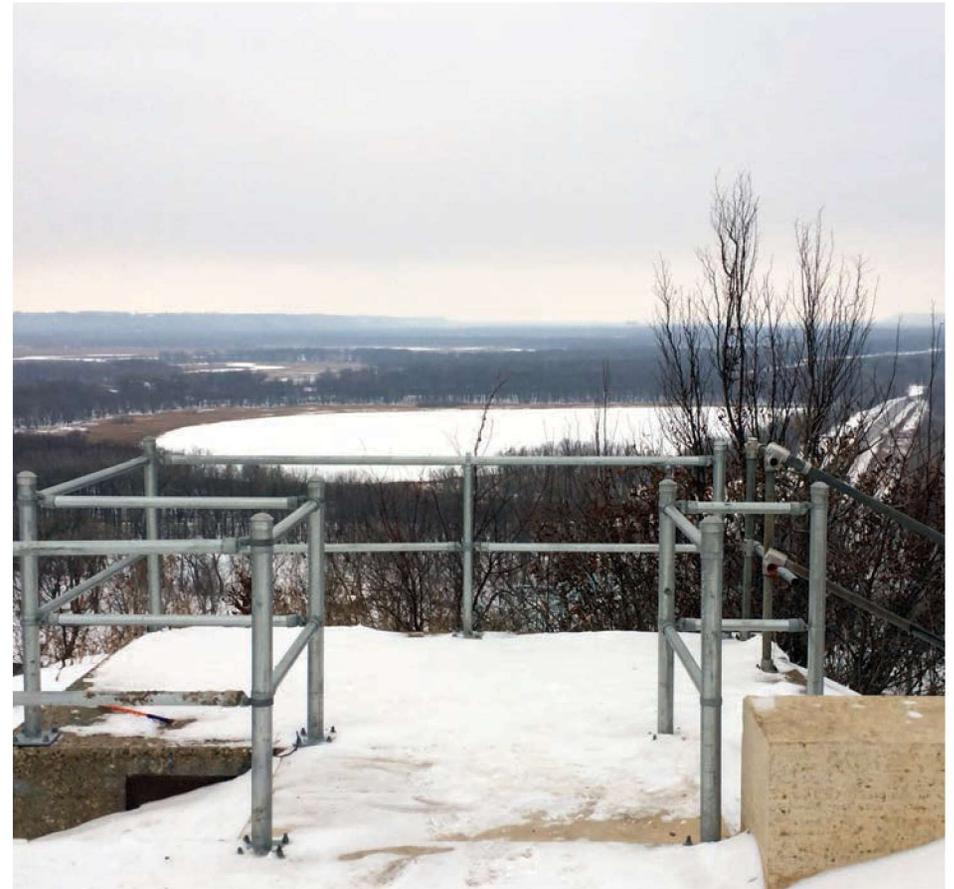
(Fig. 1.4) Overlook

- ▶ As a non-contributing contemporary addition to the cultural landscape, site furnishings should be minimally designed with little to no use of color, and should not be located in areas where historic integrity and views would be negatively impacted. Two sites are being considered by the City of Red Wing for additional amenities. Improvements to these areas

should be minimal, subdued, and not interrupt the historic qualities of the cultural landscape.

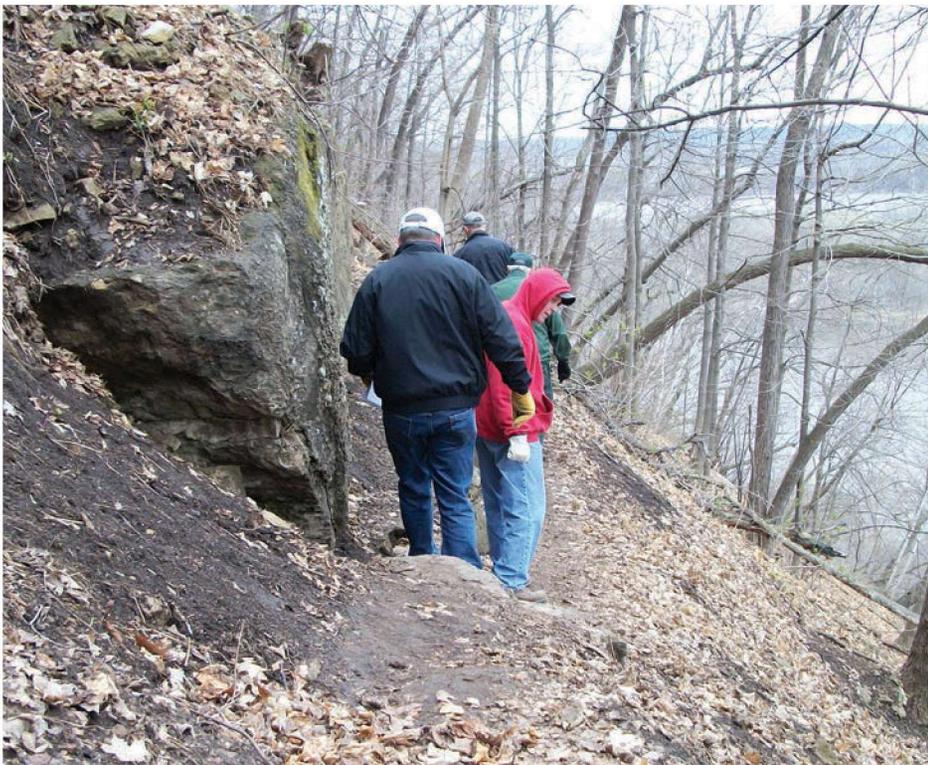
(Fig. 2.1) Existing North Trail condition

The North Trail section continues west past the quarry area and continues as a packed earth trail benched into a consistently steep slope towards the west Kiwanis stairway. The trail width varies from 18"-3'. Occasionally, the trail intersects with a rock outcropping which is incorporated into the trail bed. Erosion along the north slope is evident and likely due to the heavy tree canopy and steep slopes which allows minimal water infiltration and sunlight. Ephemeral spring flora is abundant on the steep, dark forest floor, but minimal water infiltration and dry summer months result in erosion to the duff layer onto the trail in some areas.

Navigating the trail can be challenging in all seasons. Wet spring and icy winter conditions are slippery. Summer and fall conditions are less hazardous, but the narrow trail section perched on the steep hillside is difficult to negotiate. However, the trail is a contributing feature to the historic district, and minimal interventions should take place when safety improvements are being considered.

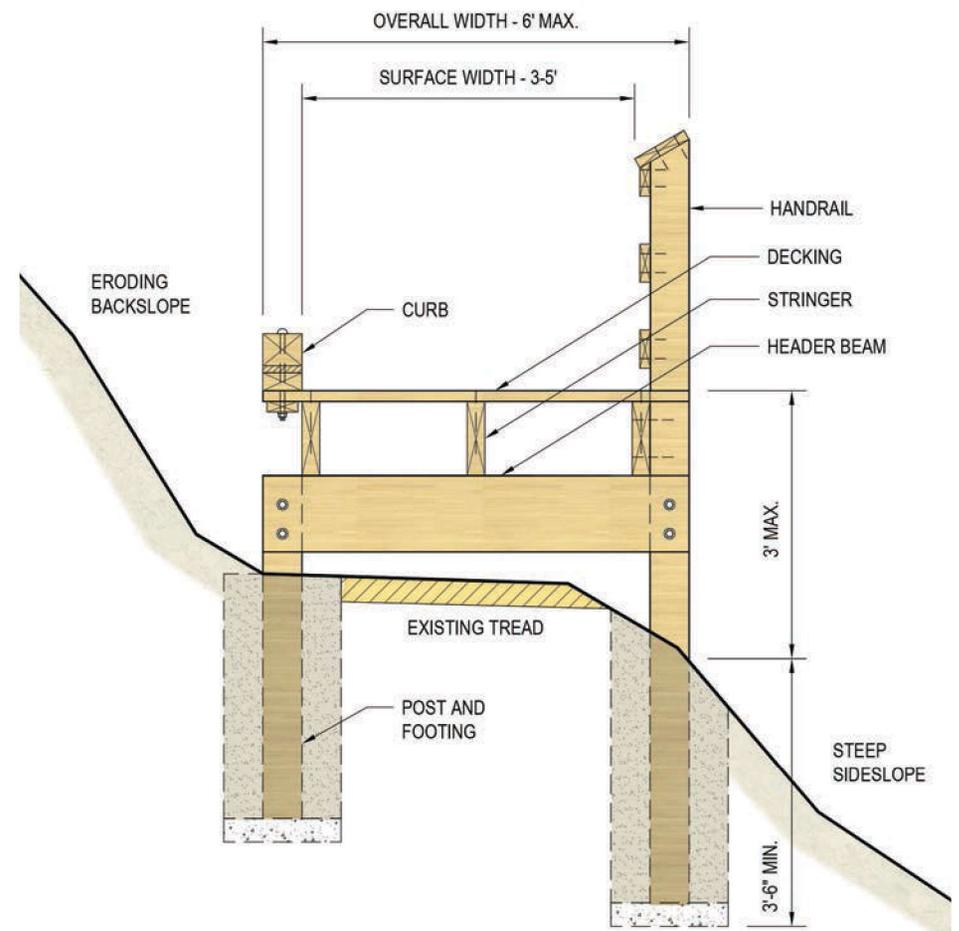
The first of these options is to construct a decking structure along the full length of the trail (Fig. 2.2)). A structure similar to this could run between \$500 and \$2,500 per lineal foot of structure, depending on the bluff attachment and structural requirements. Given the 1600 l.f. of trail along the north slope, this number is relatively high. In addition, a structure would adversely impact the historic district, would be highly disruptive to the existing slope during construction, and is not recommended.

(Fig. 2.2) Bridge Structure over existing trail - Section

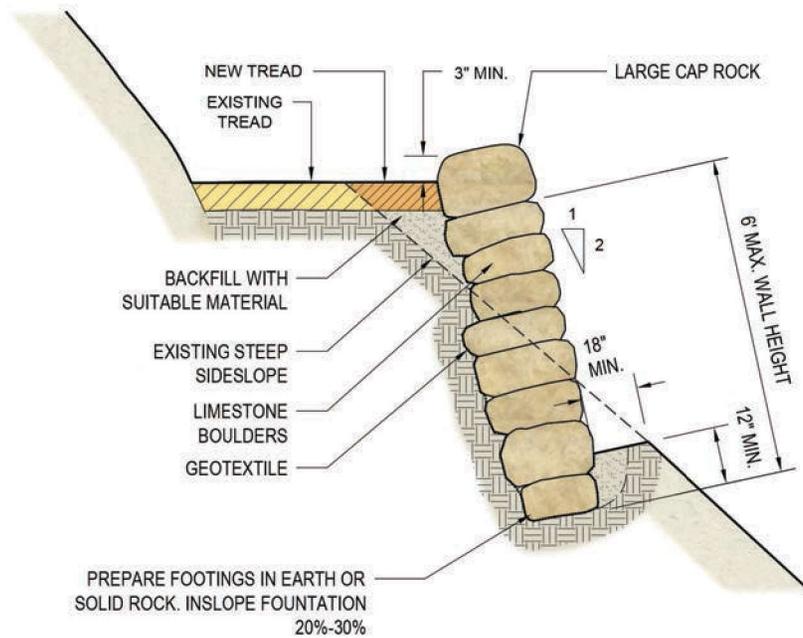
A second option for improving trail safety is to widen the tread through the use of a tread wall (Fig. 2.3 & 2.4). The tread wall would best be constructed of dry stacked regional limestone similar to examples seen near the kiln and accessory structures. The trail width could be more easily controlled as a level plane, and the width would provide security for users. A tread wall may be determined to be an adverse impact on the historic district, however, making it less than an ideal option.

(Fig. 2.3) Limestone Tread Wall - Section

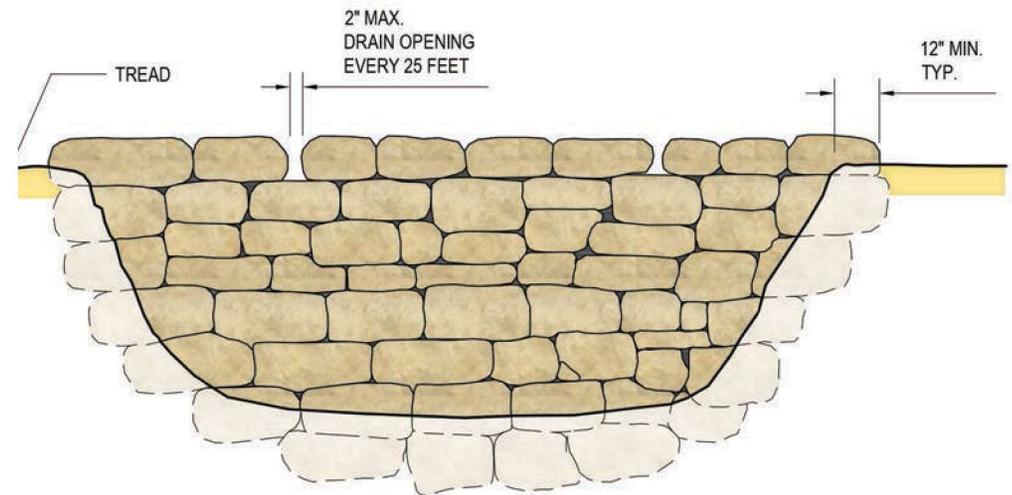
(Fig. 2.4) Limestone Tread Wall - Elevation

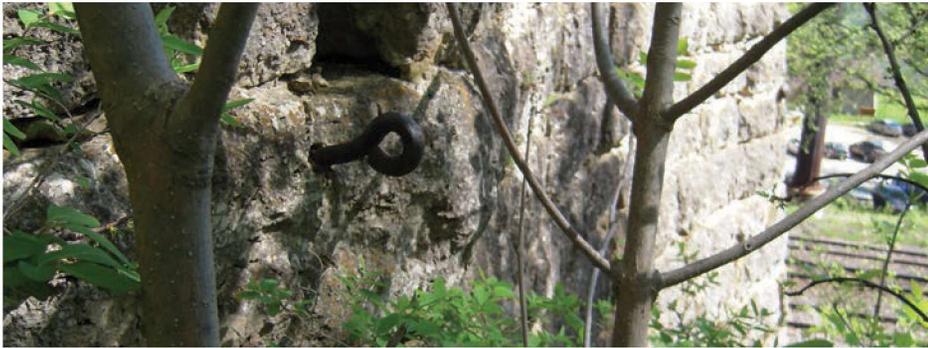
(Fig. 2.5a) Existing Cable Support seen at the Carlson Kiln site

A third recommendation includes installing assistance mechanisms such as a cable rail. Considering the historic quality of the bluff, the cable rail is the preferred solution for mitigating the hazardous condition of the North Trail. The cable rail is a simple steel cable, anchored into the bluff slope, meant to provide assistance when needed (Fig. 2.6 & 2.7). The cable would be anchored only occasionally into the uphill bank of the trail with earth anchors and would not be consistent along the trail length. Special attention to the location of the cable rail would be given to portions of the trail that

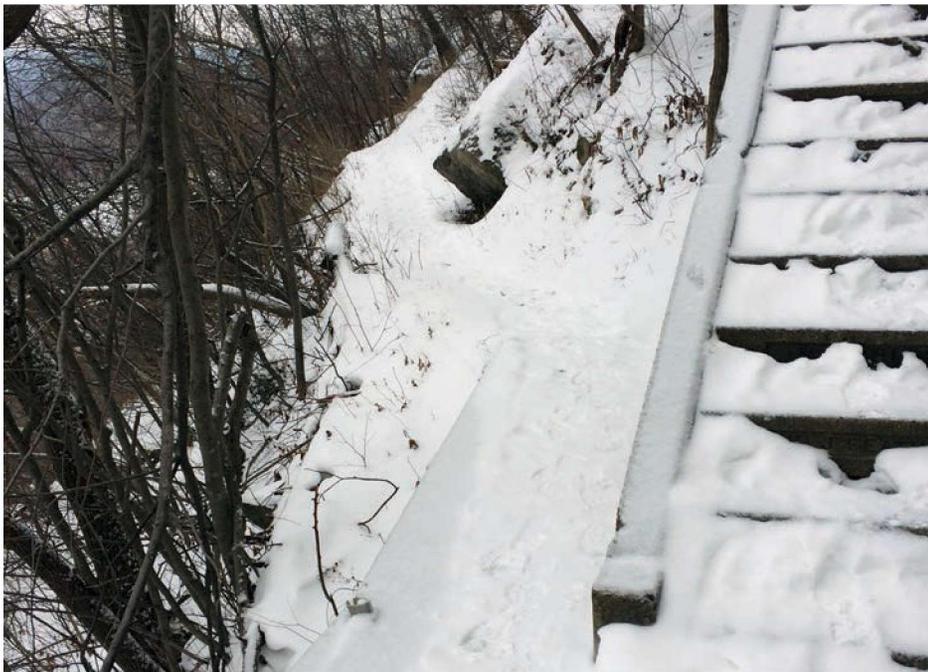
are considered the most hazardous. The cable rail is a minimally impactful solution for safety concerns along the trail. Handrails could be used as a safety intervention at the far western end of the north trail where the trail intersects with the historic steps and a somewhat precarious negotiation of the slope is required (Fig. 2.5).

(Fig. 2.5) North Trail and West Kiwanis Stairs

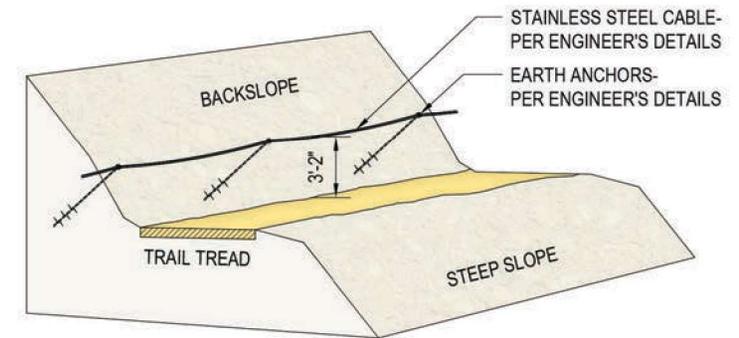
(Fig. 2.6) Cable assist with earth anchors

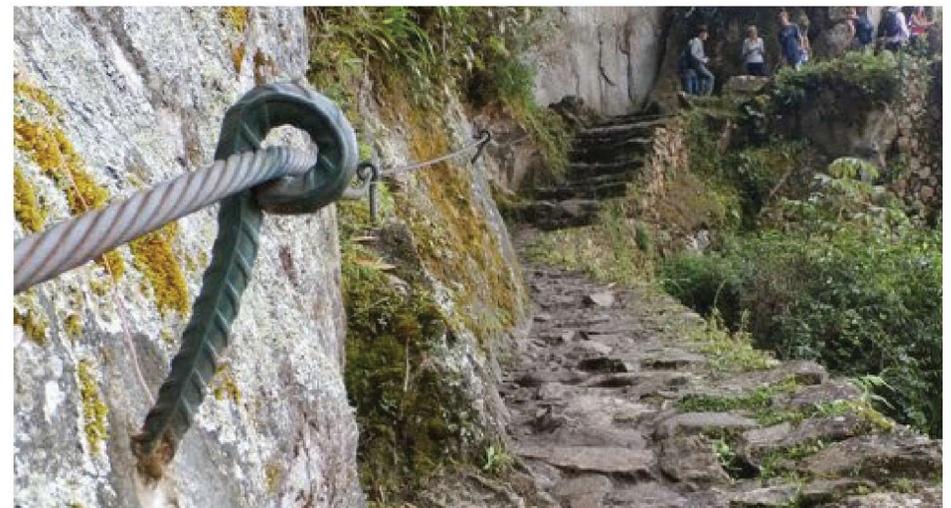
(Fig. 2.7) Example of cable assist steep slope

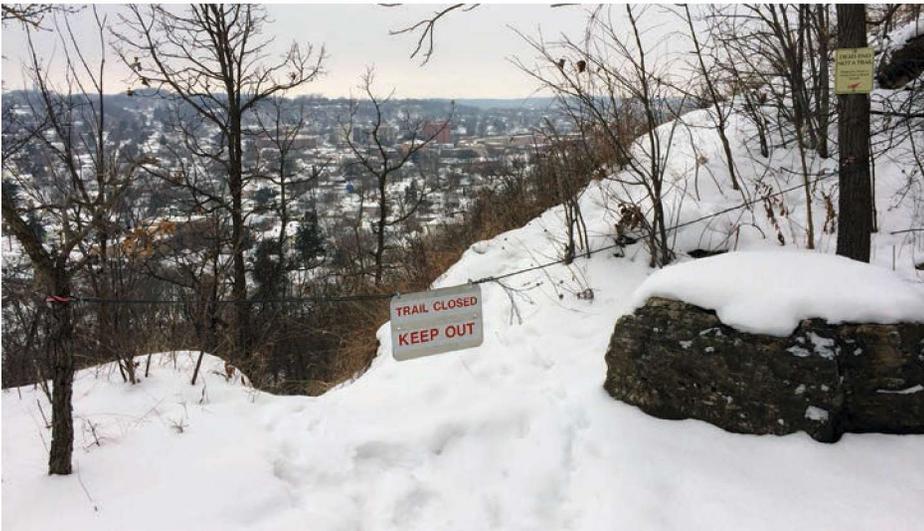
Several methods for trail closure are appropriate for use in Barn Bluff Park. Figure 3.1 illustrates a situation where a renegade trail has been created by either human or animal use. The cable closure and signage is a good temporary installation, but further work is required to camouflage the existing volunteer route and thwart determined users. Over time, as the native vegetation is re-established and erosion minimized, the cable can be removed, drawing less attention to the area.

(Fig. 3.1) Existing trail closure

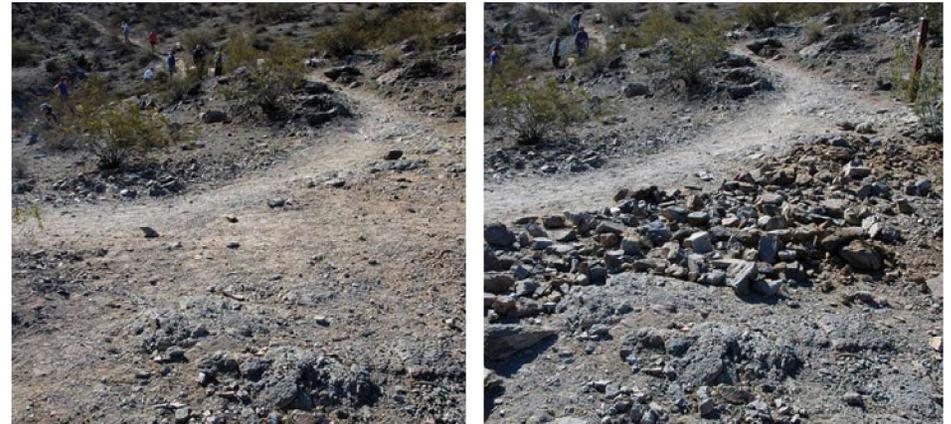
(Fig. 3.2) Successful camouflaging of existing trail, before and after

- › Screen the trail using sticks or logs, by either laying them across the path or placing them in a vertical stance (vertical deadfall)
- › Break up the line-of-sight to the former trail and guide users along the open trail by placing rocks or logs along the access point to naturalize the edge and block access (Fig. 3.2)

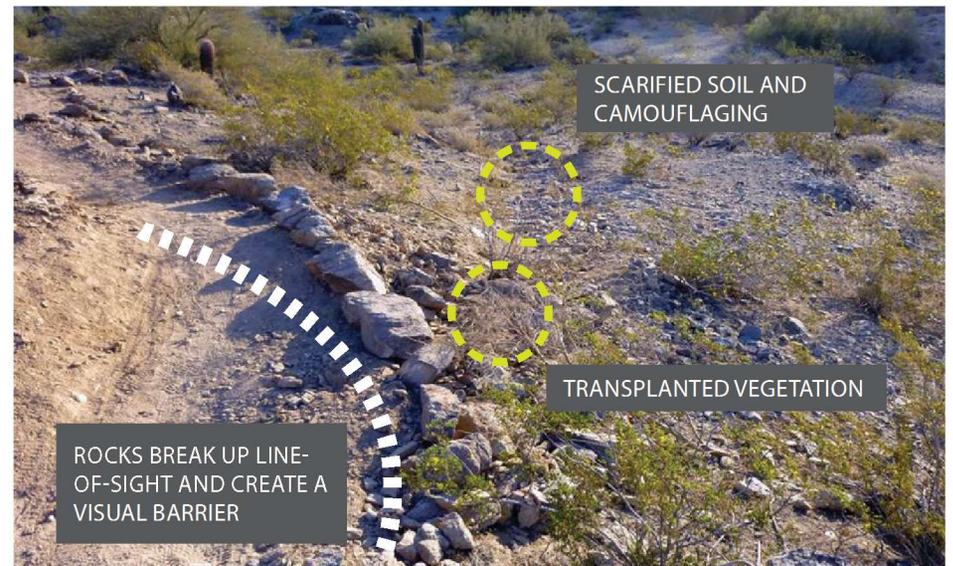
(Fig. 3.3) Camouflaging, re-contouring and re-vegetation of existing trail

The site restoration should include the following steps to establish an effective permanent trail closure (Fig. 3.2-3.4):

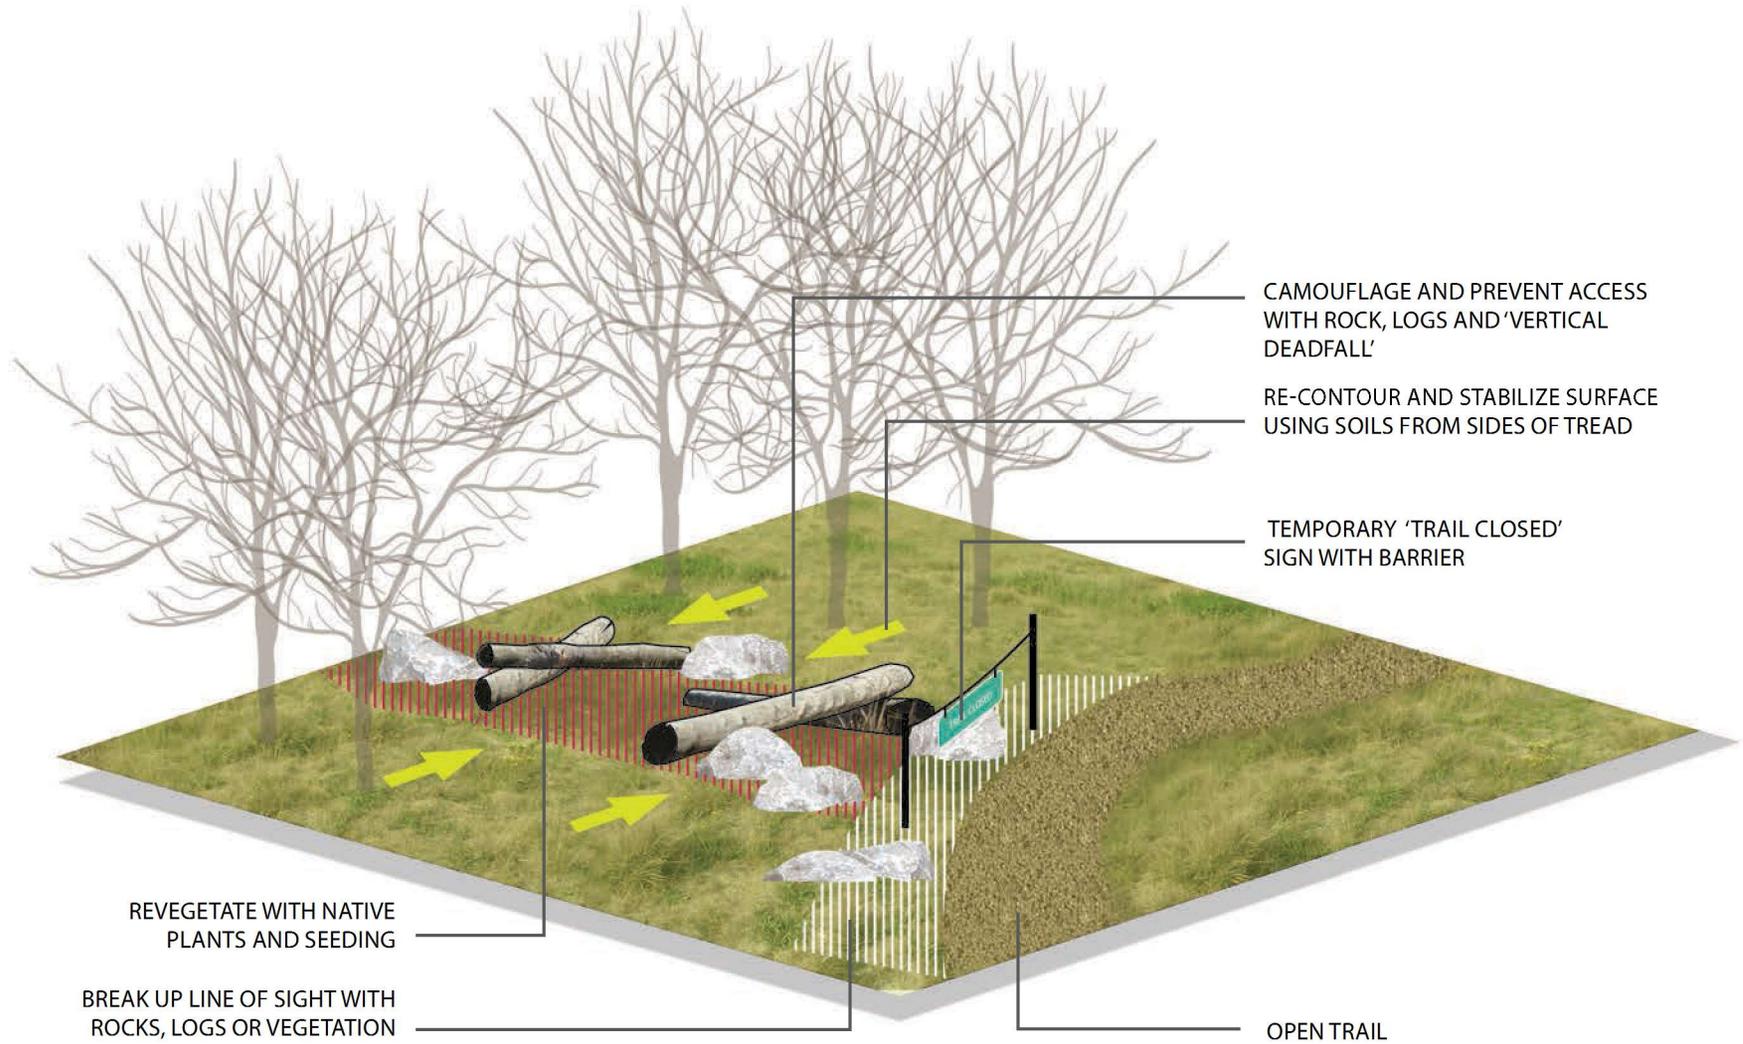
(Fig. 3.4) Techniques for permanent trail closure

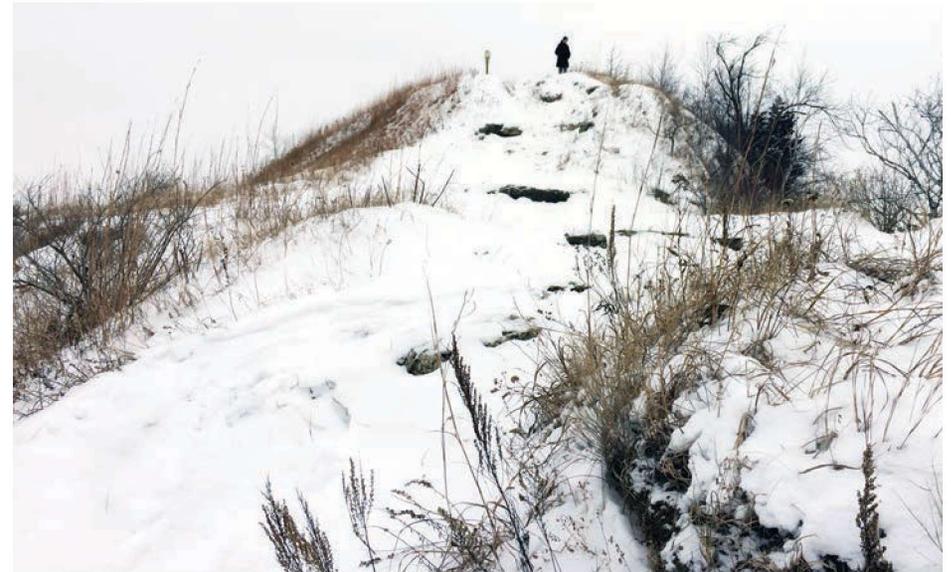
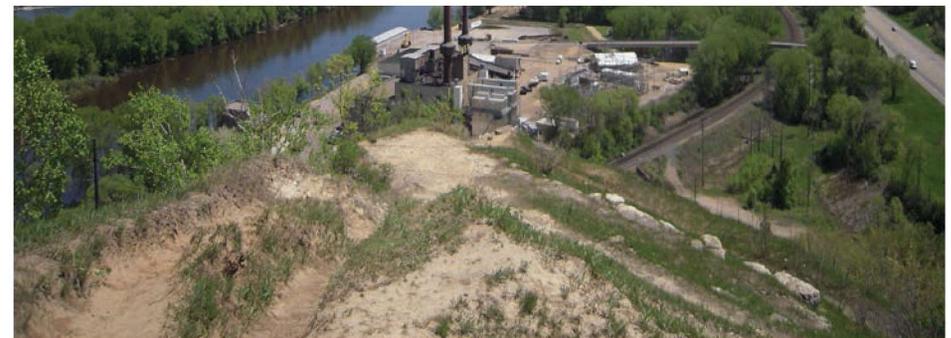
The deep gully and erosion visible in this trail section (Fig. 4.1 and 4.2) is exacerbated by foot traffic, water and wind in this exposed bluff face.

(Fig. 4.1) Erosion along Prairie Trail

(Fig. 4.1a) Erosion along Prairie Trail

Construction of Box Steps or Plank Style Retaining Stairway would work well to control erosion along Prairie Trail.

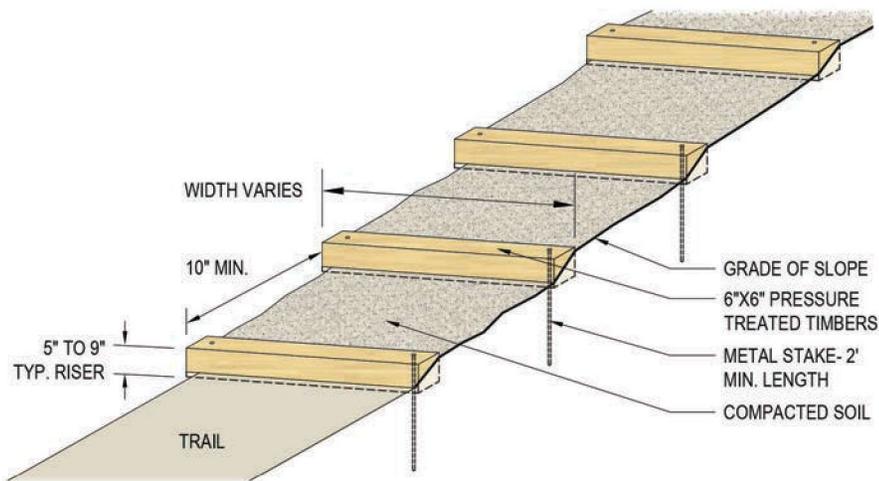
Either the construction of Box Steps or Plank Style Retaining Stairway will control this type of erosion. Other materials could be used, i.e.: limestone. However, consideration has been given for the location of this intervention. Moving heavy stone pieces to this location will be difficult. While stone would provide a more permanent solution, using treated wood planking may be implemented with less cost and more ease, and will provide decades of strength.

(Fig. 4.2) Plank Style Retaining Stairway Construction

- Plank Style Retaining Stairway (Fig. 4.2)
- Box steps (Fig. 4.3)

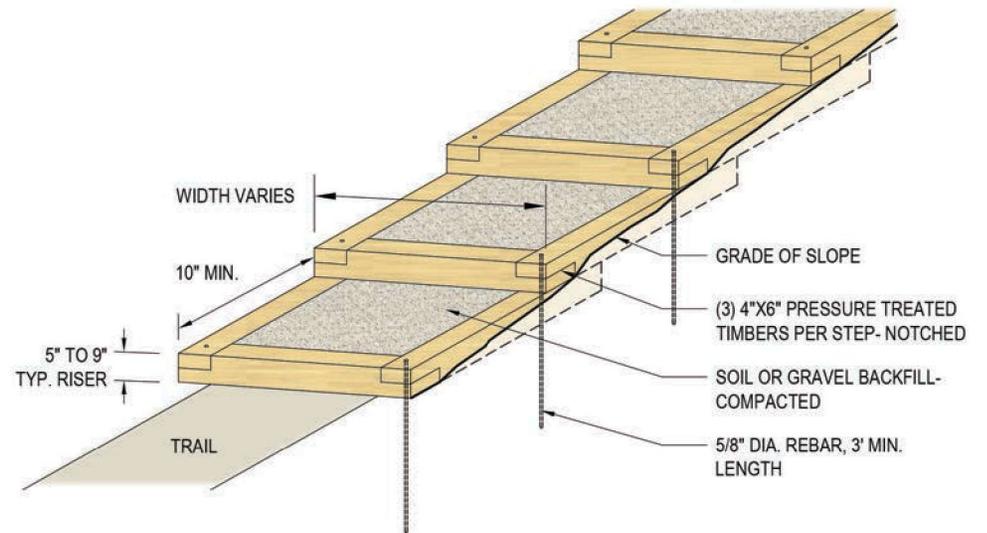
(Fig. 4.3) Box Steps Construction

Remove class V base and re-vegetate affected area. Optional additional interventions include the construction of water bars or box steps to navigate the slope. (Fig. 4.2 and 4.3) or revising the trail alignment to incorporate switchbacks. (see page 24)

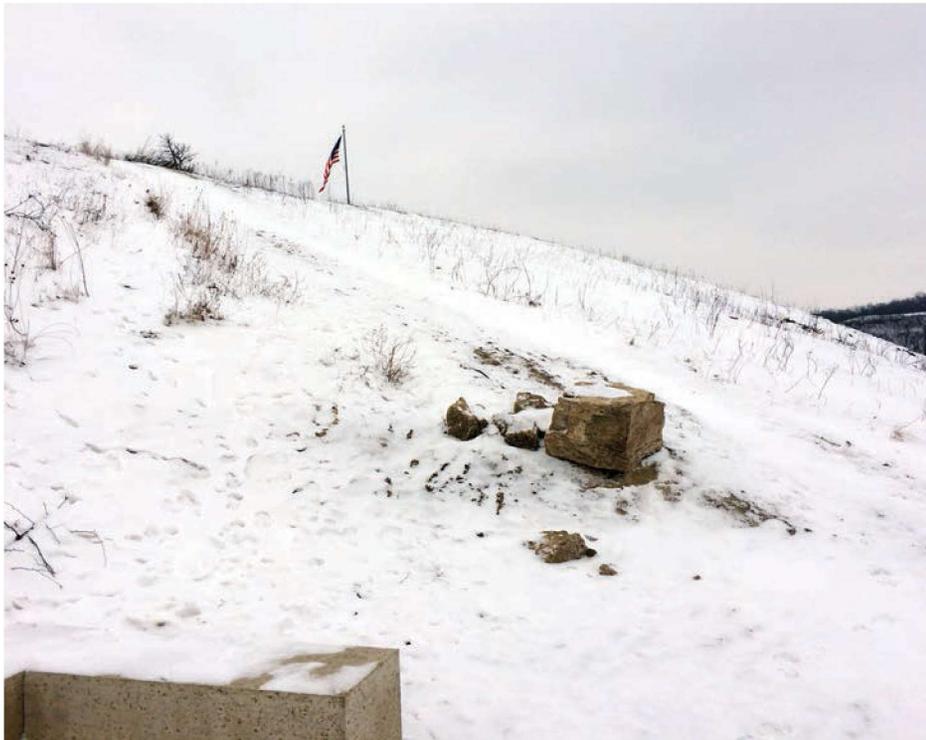
The former construction access at the west overlook is a wide, compacted class V limestone base on a steep slope. The access is wider than the standard trail system in Barn Bluff Park. The access is highly visible from downtown Red Wing, and has generated complaints from the public for aesthetic and safety reasons. (Fig. 5.1).

(Fig. 5.1) Existing construction access

Removal of the compacted class V will be labor intensive, but the excavated material can be used to fill in low spots or maintain packed earth trails in the vicinity. Once the unwanted material has been removed from the trail section, care must be taken to scarify the existing subgrade, then add the borrow, compacting while installing. The final elevation of the borrow material should be slightly raised above the adjacent grade to allow for further settling of the borrow soil. Erosion control fabric over regionally appropriate native seed should be installed with compost logs staked to impede water flow during establishment.

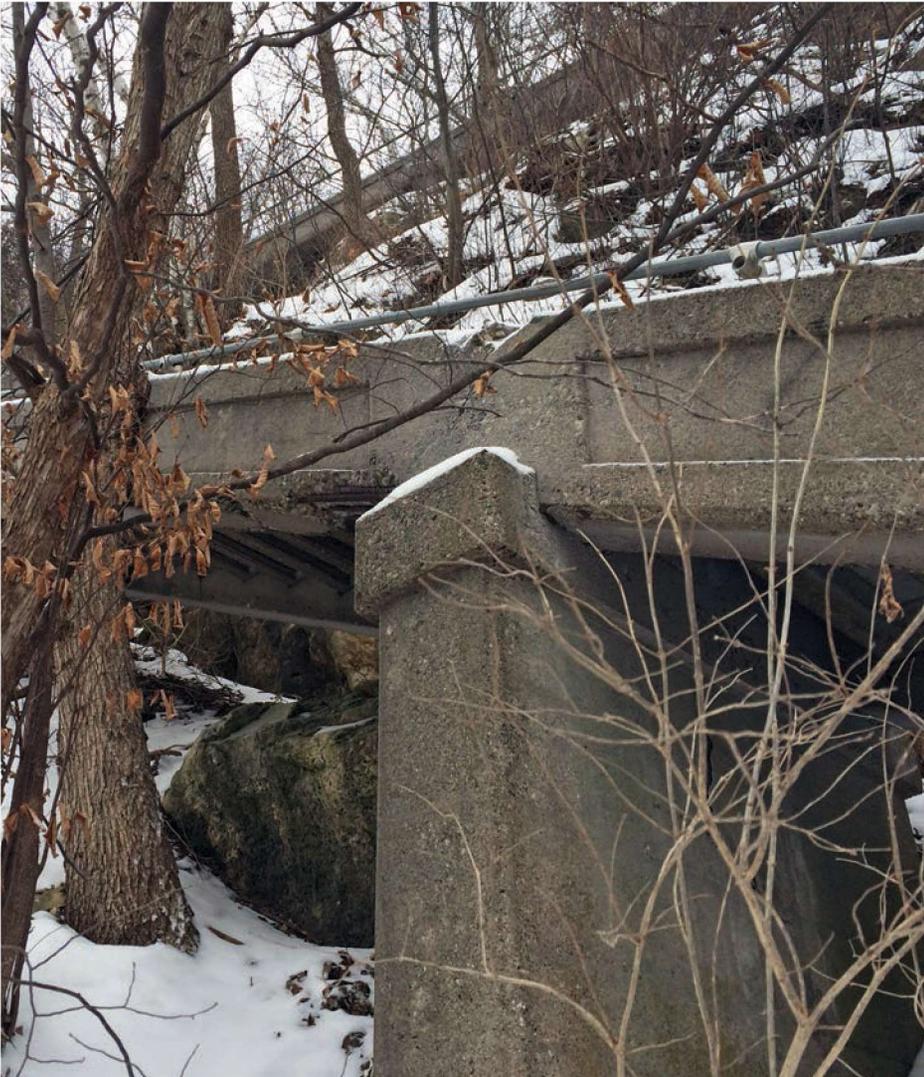
(Fig. 6.1) Existing concrete stairway

The Citizen's Memorial Stairway is in the most critical need of repair, although all three stairways require some maintenance. Examination of all three structures reveals exposed rebar, spalling concrete, cracking, and separation of structure elements (Fig. 6.1). Initial maintenance to minimize further structural damage to the structures should involve locating areas of water infiltration and patching these areas where feasible. In some cases, the repair will need to provide for anticipated thermal movement. A mock up treatment in an unobtrusive location should be prepared prior to any surface maintenance.

This work should be completed by a contractor with experience repairing historic concrete. In some cases, several attempts may be necessary to achieve compatibility between repair work and the original concrete texture and color. An extensive study and repair approach for all structures should be undertaken by a structural engineer with experience working with historic structures prior to any maintenance efforts.

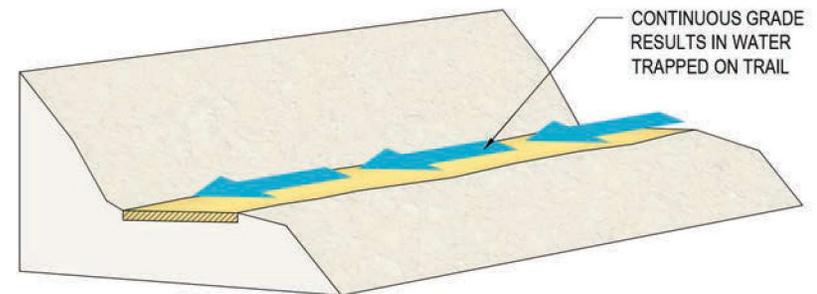
(Fig. 7.0) Continuous Grade

(Fig. 7.1) Continuous Grade

Trail washout exists in several areas of the park. Many of these incidents can be remedied by making slight modifications to the trail slope. Using the methods of reverse grade (Fig. 7.2) and reverse slope (Fig. 7.3), the grade of the trail can be modified so that washout does not run down the full run of the slope.

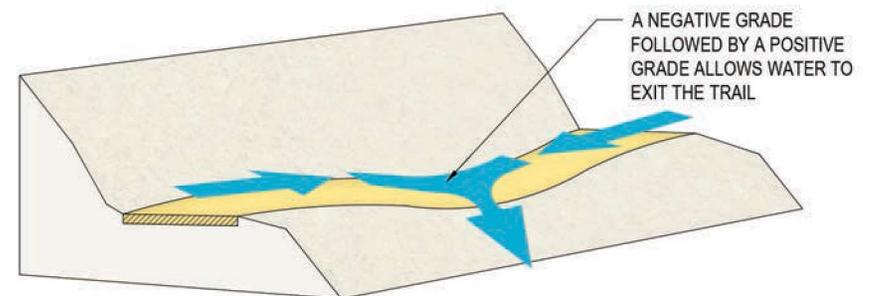
(Fig. 7.2) Reverse Grade

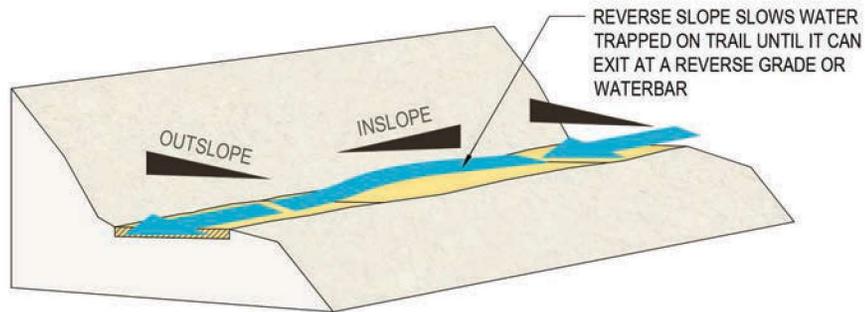
(Fig. 7.3) Reverse Slope

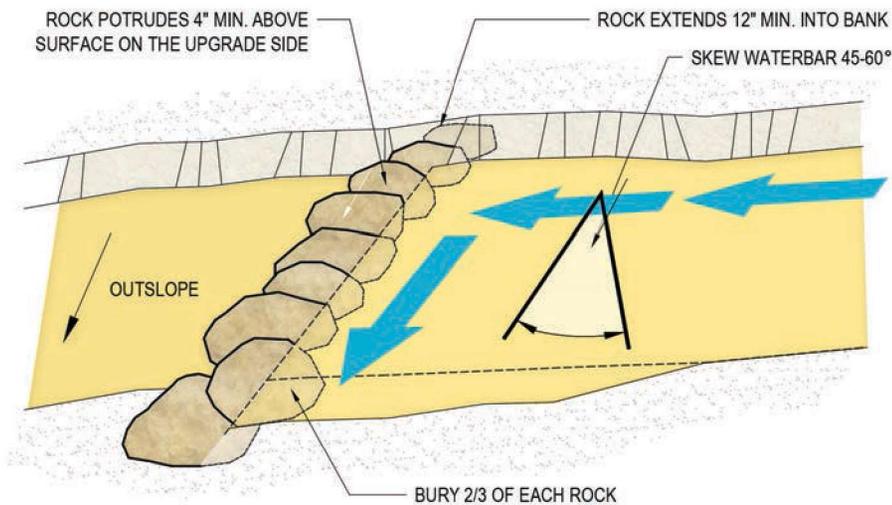
If the washout condition is too extreme, a combination of reverse grade, reverse slope and water bars should be implemented (Fig 7.4). These interventions can be installed slowly over time, and can be easily adjusted to moderate the erosion problems.

(Fig. 7.4) Waterbar Construction

Due to the steep slope in this area, installing water bars, box steps or a switchback may be necessary (see fig 7.4, 4.3 and 8.1). These technical installations should be completed after removal of the existing class V surface. Once constructed, seeding with a regional seed mix covered with erosion control fabric and installing compost logs as temporary erosion control should complete the projects.

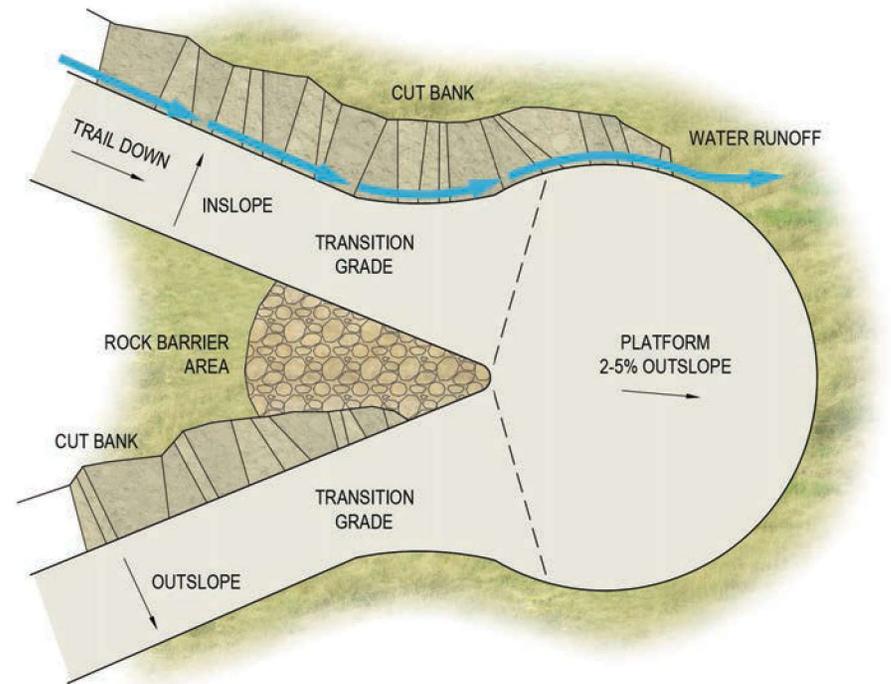
(Fig. 8.1) Switchback Construction

The switchback will function to distract unnecessary foot traffic from an existing mound site, while providing a solution to the deep gully erosion.

In some cases, building steps or other structures for navigating steep slopes are problematic or unnecessary. (see page 9/Trails for more information on appropriate trail slopes) Where sufficient space exists, a switchback is an appropriate solution (Fig. 8.1). A switchback can also direct access and manage viewsheds. Both important trail experience features should be considered when designing a switchback.

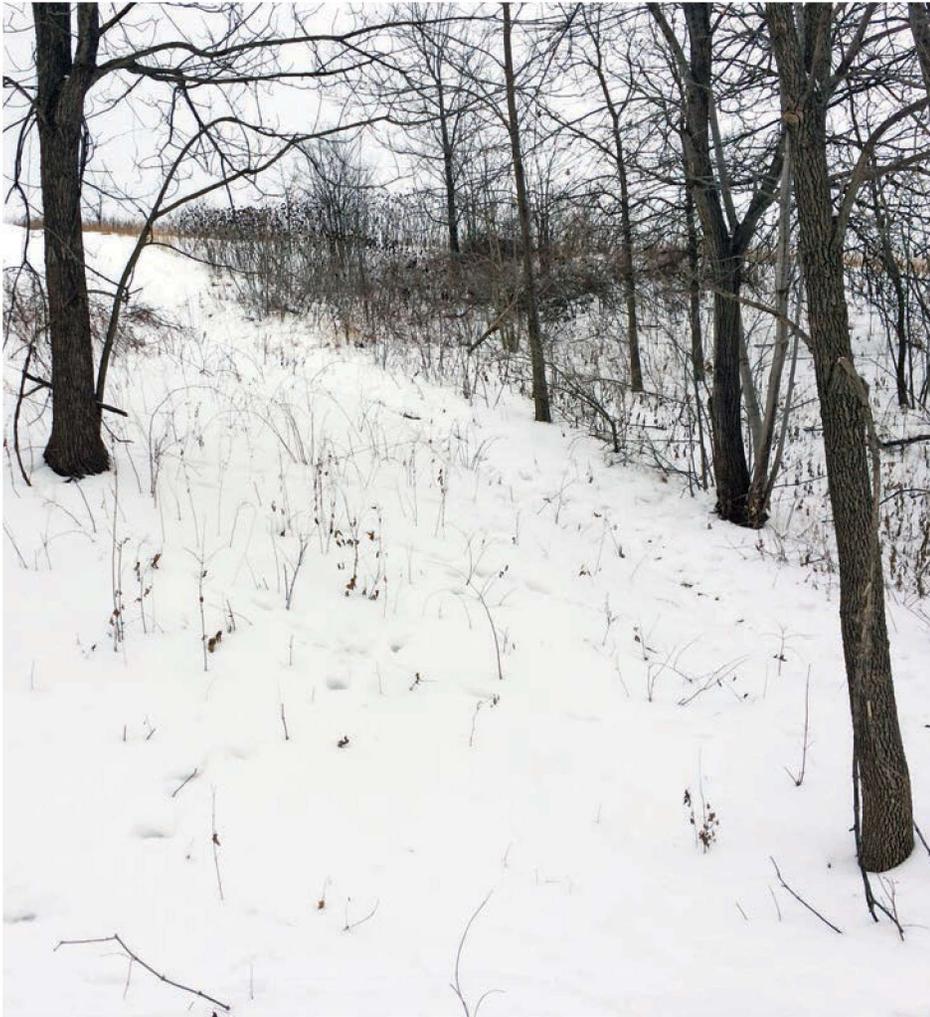
In Barn Bluff Park, one new switchback location has been identified based on the recommendations outlined in the Barn Bluff Cultural Landscape Report. The switchback trail will function to distract unnecessary foot traffic from an existing mound site, while providing a solution to the deep gully erosion that is occurring at the connection between the upper portion of the Central Kiwanis Stairway/seating area, and the Prairie Trail.

(Fig. 8.2) Location of proposed switchback

The siting of this switchback will need to be carefully staked in the field. Trail camouflage techniques may be required to discourage new trail cuts between legs of the switchbacks. Legs should be located far enough from each other that cut through traffic is discouraged. Reverse grading techniques should be employed to minimize the erosion potential for the new trail (Fig. 7.2). Temporary signage should be used to explain the trail realignment and erosion issues until the vegetation has been completely established in the former trail site and along the newly constructed switchback.

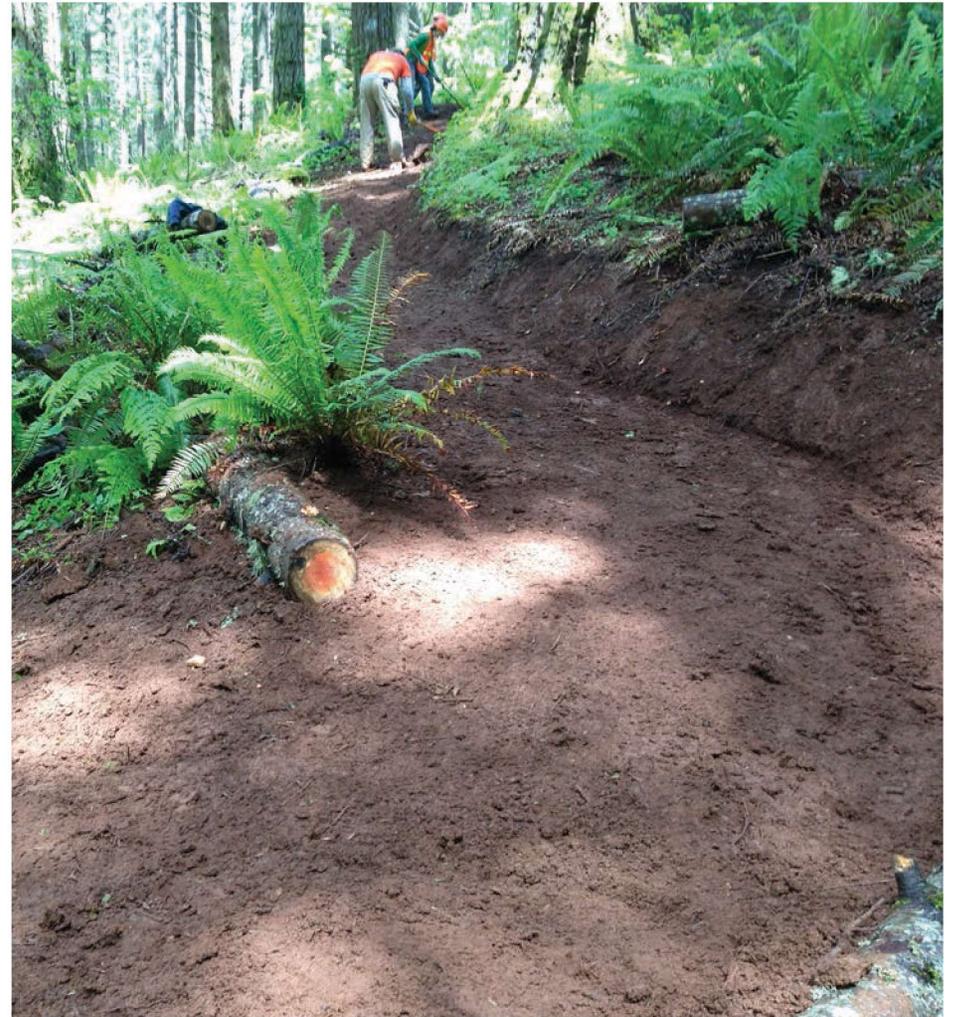
(Fig. 8.3) Example of proper switchback trail construction
